Learning From Incident Alert (Houdini) #13

AREAL LIFT (BOOMLIFT/CHERRY PICKERS)

Downstream HSSE Communication - Goal Zero Incident Report/Learnings For Internal Use Only

Type of Incident: Fatal incident involving installation of pipe rack beams using aerial lift (boomlift or cherry picker).

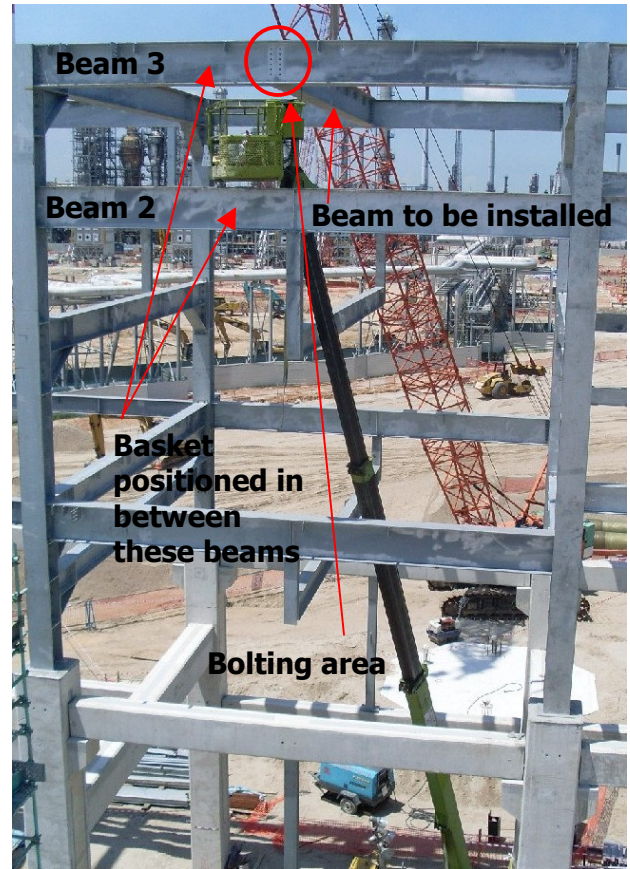
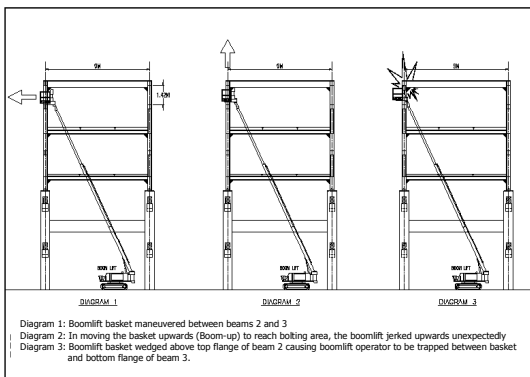
The work involved bolting of a secondary internal beam onto a pipe rack beam structure at a height of approximately 18 meters. To perform this work, the boomlift crew maneuvered the basket in between another two existing beams. According to the witness who was also inside the boomlift basket, after maneuvering the boomlift basket in between the beams, the deceased who was operating the boomlift wanted to position the basket closer to the bolting area by moving the basket upwards.

During the process of moving upwards, the boomlift basket jerked upwards. It appeared that the jerked up motion happened too quickly for the deceased to react in a timely manner and was crushed between a steel beam and the boomlift basket control panel.

The immediate cause of the incident appeared to be due to the upper-platform-levelling-cylinder (telescopic boom head) that is located directly below the basket could have been partially blocked from moving upwards by the beam 2. In final positioning of the boomlift basket (moving upwards), the trapped telescopic boom head most likely managed to free itself. This caused a sudden and unexpected fast upward motion (jerked-up).

- There is an existing training program for boomlift operators, which are Working at Height Training and Boomlift Demonstration. However, it is concluded that the Boomlift demonstration focusing on boomlift functionality was not adequate to ensure that boomlift operators understand the specific hazards related to boomlift operations. [Training]

- There was no training program for supervisors supervising boomlift operations prior to the incident. Therefore, these supervisors were not able to effectively execute their respective supervisory roles in ensuring safe operability of the boomlift before each boomlift operation. [Training]

- Prior to the incident, the project had identified the risk of being in "Line of Fire" and implemented a supplementary "Line of Fire" training program for all construction workers. This training was to reinforce their existing knowledge of this risk. As of the incident date, the implementation of the supplementary training had not yet reached 100% of site workers. [Error Enforcing Condition]

- There was a change in the sequence of the construction at site due to delay in arrival of connection angle plates. The change of sequence in the construction did not introduce any new hazards not already captured in the risk assessment for boomlift operations. However, the change resulted in increased complication in the manoeuvring of the boomlift. This change and the corresponding increased in manoeuvring complication were not picked-up at site (by Field Engineers or Supervisors) prior to execution of the steel erection work. [Error Enforcing Condition]

- The increased complication to manoeuvre the boomlift was further complicated by an unauthorised ad-on of a metal cover mat that was placed on the floor of the boomlift basket. Whilst it performed the function of catching falling small instruments like nuts and bolts, the metal cover mat blocked the view directly below the boomlift basket and therefore any complication to manoeuvre the boomlift in tight locations is made worst whereby the boomlift operator will not be able to see directly below if any of the boomlift parts had made contact with any structures. [Defence]

- Ensure that training conducted to your workforce is adequate and fit for purpose to allow them to perform their work safely.
- Supervisors also need to be trained in the activity they are supervising so that they are able to execute their role effectively.
- Ensure your work crew and supervisor is able to pick-up (at site) on any changes in work planning or increased in complication to perform an activity and discuss with the appropriate parties to resolve them. Routine activities does not necessarily mean similar work method to be used. Different work method (e.g. location of other nearby structures along the path of the boomlift) may be needed to make the work safe.

- Training program for all members of the workforce and consistent with their expected roles and responsibilities (workers, banksmen & supervisors).
- Management of change at the sharp end of the construction line and at field engineers level [Including modification (or simple ad-on) to machineries is not allowed without approval from the appropriate parties].
- Routine work may require different strategy/requirement to complete them safely depending on the specific situation at the site (e.g. location of other structures etc.) and field engineers, supervisor and worker must be trained to identify them.
