Accident MEMO

Date: August 13, 2007

Quad Roll Over

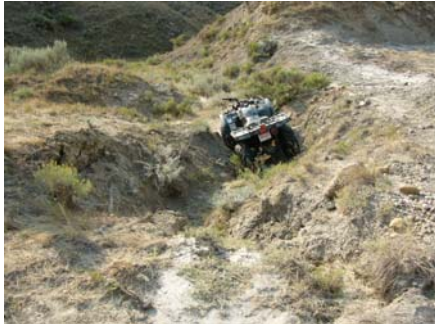
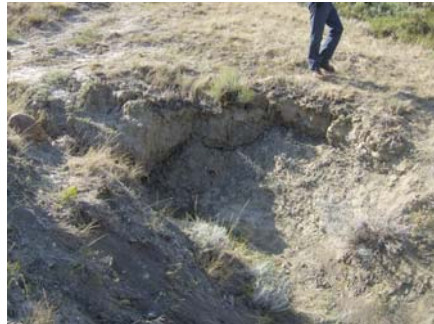
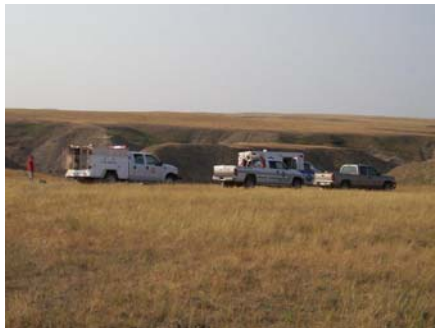
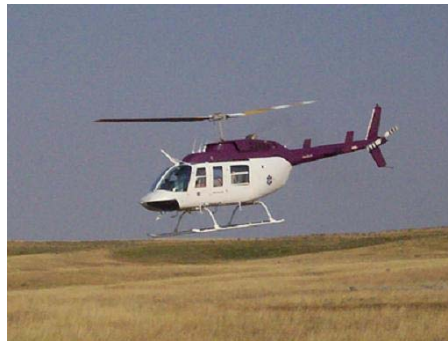
On August 13, 2007, one of our survey assistants was involved in a Quad roll-over accident and suffered a serious injury to his femur. Due to the severity of the injury and the remote location of the accident location, Air Ambulance was dispatched to the scene to rush him to the hospital.

The cause of the accident was determined that the survey assistant hit some loose gravel and his front left tire slid down to the edge of the washout resulting in the quad to rollover before he could recover himself.

This is a reminder to ALWAYS scan ahead of the terrain for potential obstacles or rough terrain and ride accordingly. Always wear your PPE, complete your hazard assessments and First Aid Transportation Plan prior to the start work on the jobsite.
