## Safe Working at Height - SVT Injury

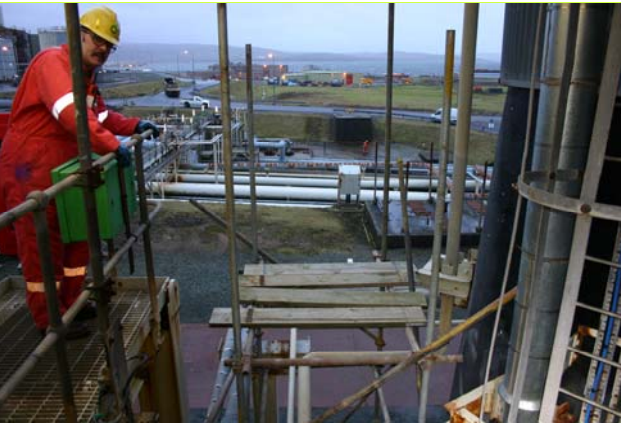
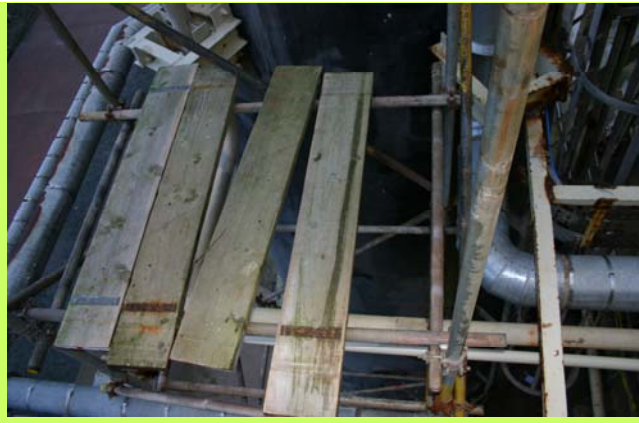
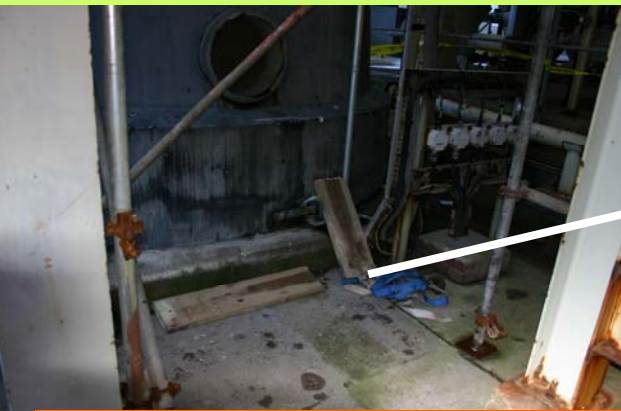
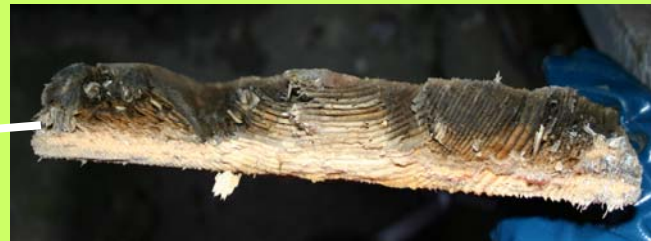
Scaffolders were in the process of **dismantling scaffolding at SVT** yesterday. During this activity one of the scaffolders had transferred one board from the highest level down to the next level. Whilst **standing on the single board the board broke**. He was **not clipped** on and as such, **fell ~20ft**, landing at the base of the column, **breaking his lower leg and ankle**. This could easily have been a fatality.

Incident happened as a result of a **failed scaffold board**.

Scaffolding teams are responsible for managing the **quality of the materials** that they use, including poles, clips and boards. Only the correct materials should be used.

Clipping on every time is a **requirement for employment** on our sites.

**Golden Rules on working at height** will ensure that we prevent such incidents or at the very least - minimise the potential for serious injury.
