Safety Bulletin

August 2007

Excavation Security

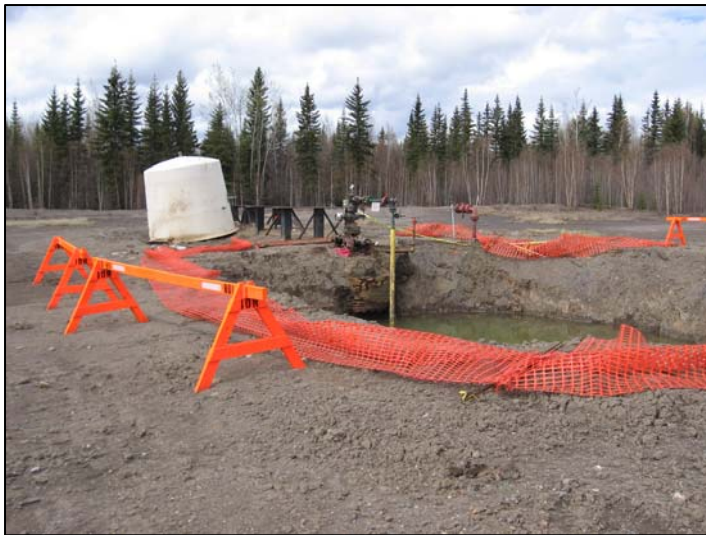
Condition of site at time of inspection

During a routine site inspection, an EUB inspector discovered an unattended open excavation for which security was not maintained. A fluid hauler had left the fence down while transporting recovered water from the site to the disposal facility. The hauler understood that this was acceptable practice, and had re-erected the fence at the end of each day.

A High Risk Enforcement Action was issued to IOR under EUB Directive 66 (Requirements and Procedures for Pipelines)

1. Assess similar sites (active spill sites, drilling sumps, pipeline bell holes, etc.) and determine if security is adequate to restrict public access (could include fencing, signage, barricades, manning of site, etc.)
2. Clearly communicate with employees and contractors our expectations that security measures around open excavations are to be in place when the lease is unattended.

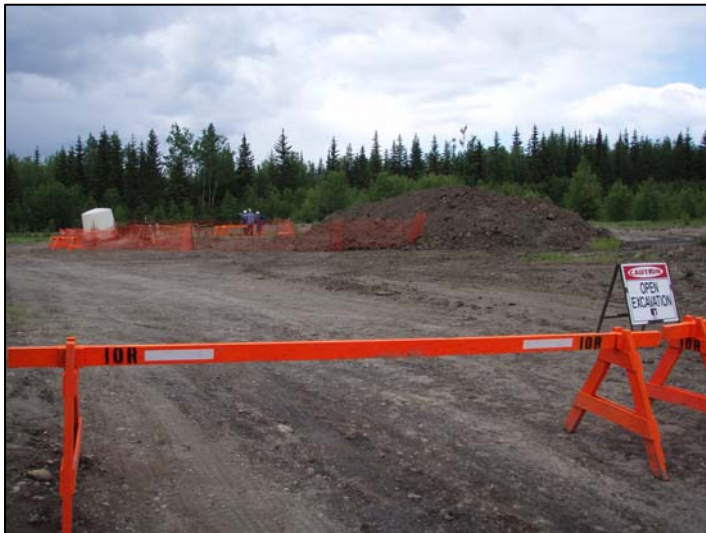
Properly secured site with lease entrance barricades and fully erected snow fence
