SAFETY ALERT

Hand Injury

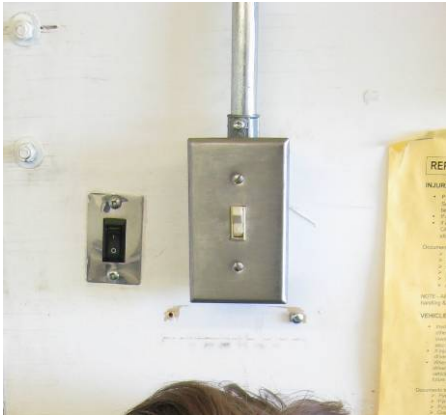
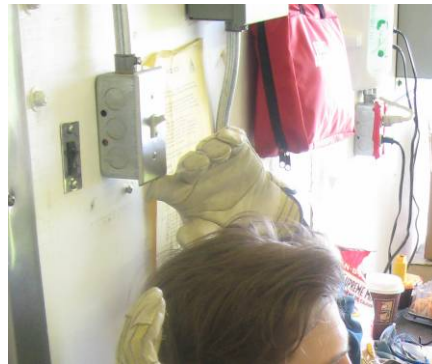
Event: A worker was having a coffee break in a lunchroom. The employee was resting his hands behind his head. The employee moved his hands to stand up. When the employee moved his hands, the index finger of his left hand came into contact with the light switch cover. The cut to his finger had to be closed with seven stitches.

Causes: Inadequate design – The light switch had sharp edges

- ***Identify light switches that have similar hazards where people could be exposed to the hazard. Replace where required***
- ***Conduct a hazard hunt and correction for other sharp edges. Look for:***
 - ***Banding***
 - ***Sheet metal***
 - ***Cable wickers***
 - ***Metal wickers on threads***
 - ***Metal corners on furniture***
 -
